# Cracked Torque Tube Horn Survey Results

International Comanche Society

1 November 2009

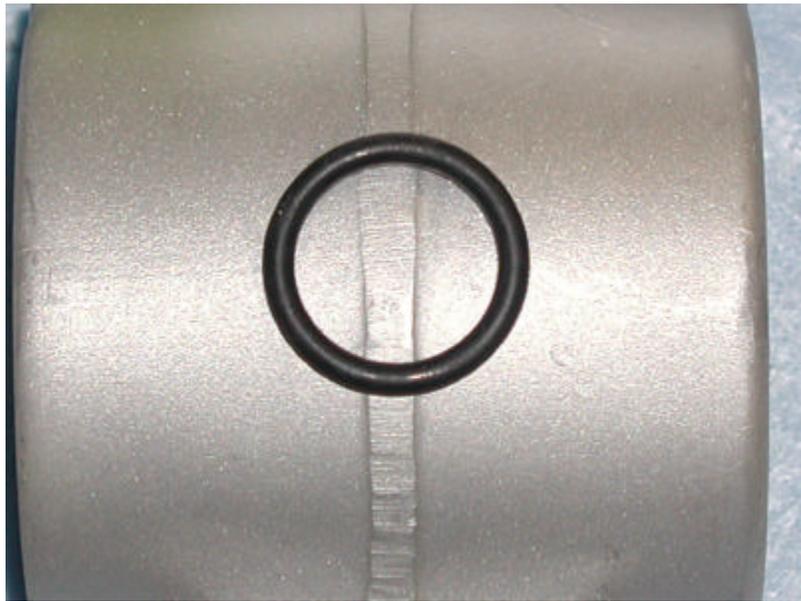
Early style horn top/bottom

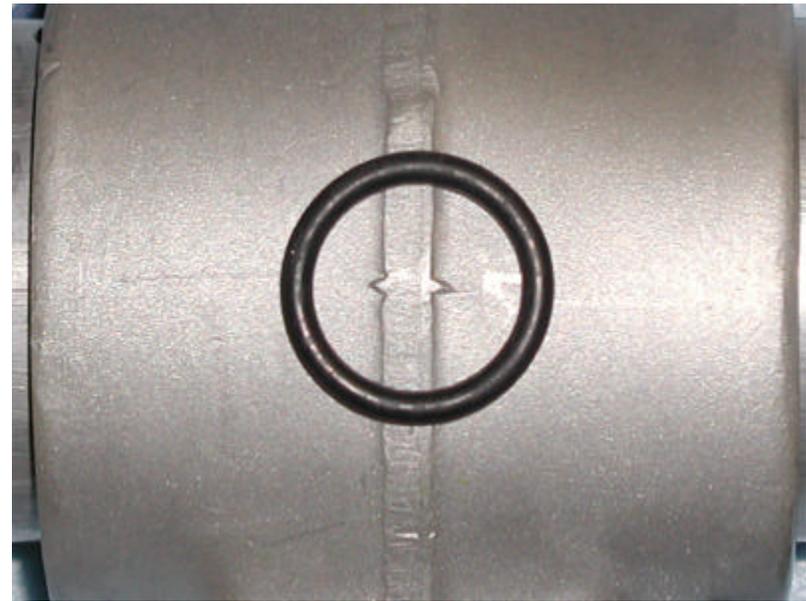
Late style horn top/bottom  
Distinctive forging die mark

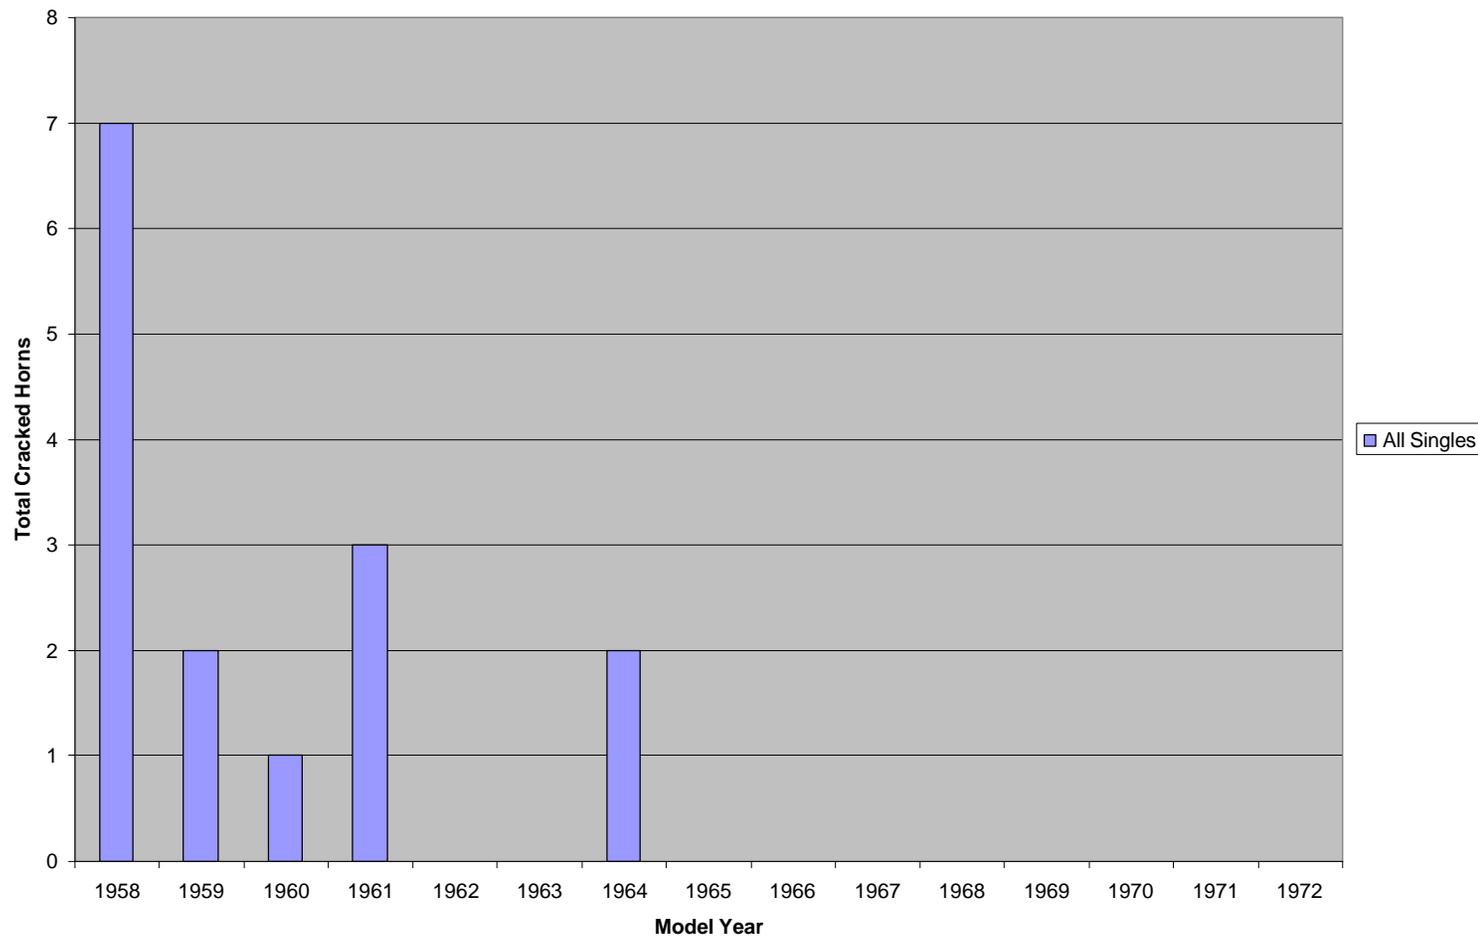
CRACKED HORNS BY MODEL YEAR

# Summary of All Known Cracked Horns
