Comanche Torque Tube Corrosion Investigation

RESPONSE TO FAA SAIB CE-04-88
AND PIPER SERVICE LETTER 1160

14 July 2007
Hans Neubert

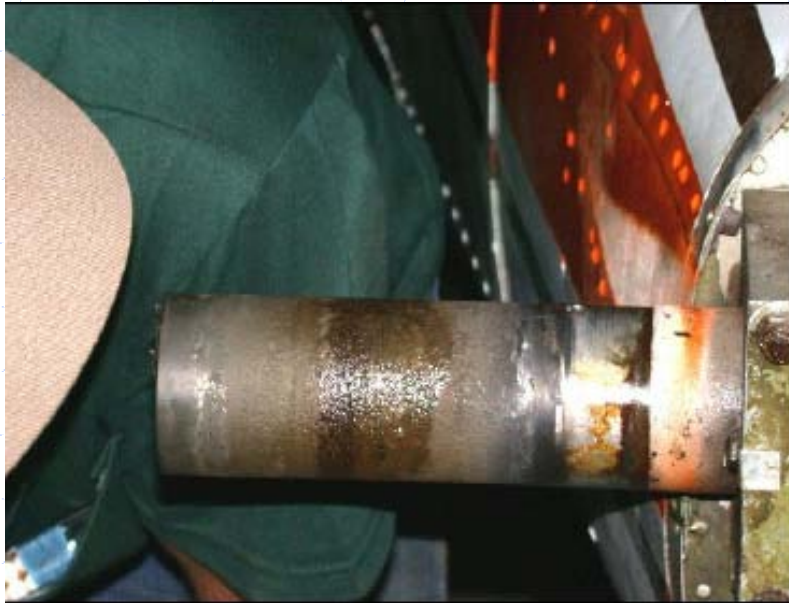
Typical Severe Corrosion
On Torque Tube

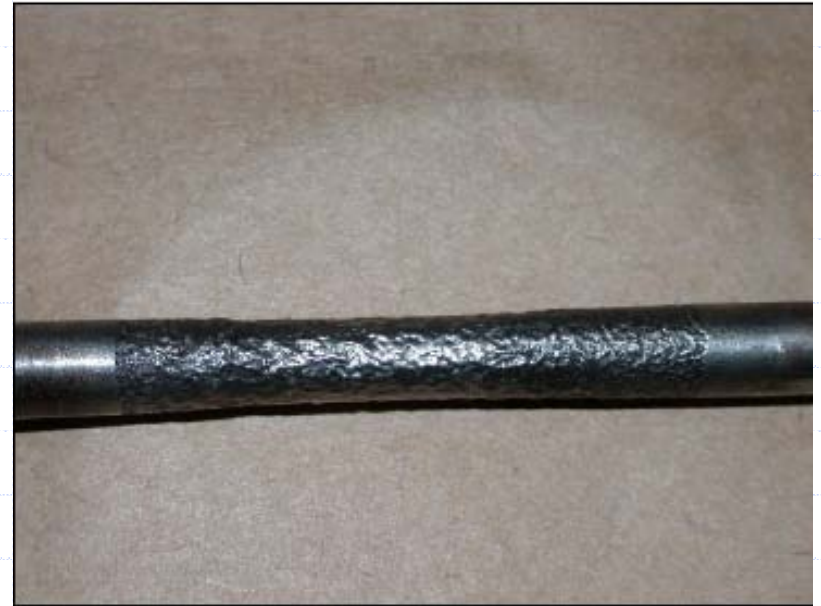
Typical Corrosion on AN5
Bolt Holding Horn to
Torque Tube

- ◆ Corrosion has been observed between the torque tube and the attaching bolts
 - Piper Service Letters 667A and 772
 - Advisory Directive 74-13-10 issued by FAA
- ◆ Inspection requires replacement of existing attaching stabilator bolts with corrosion resistant bolts
 - Replacement of bolts with CRES bolts is terminating action of the AD

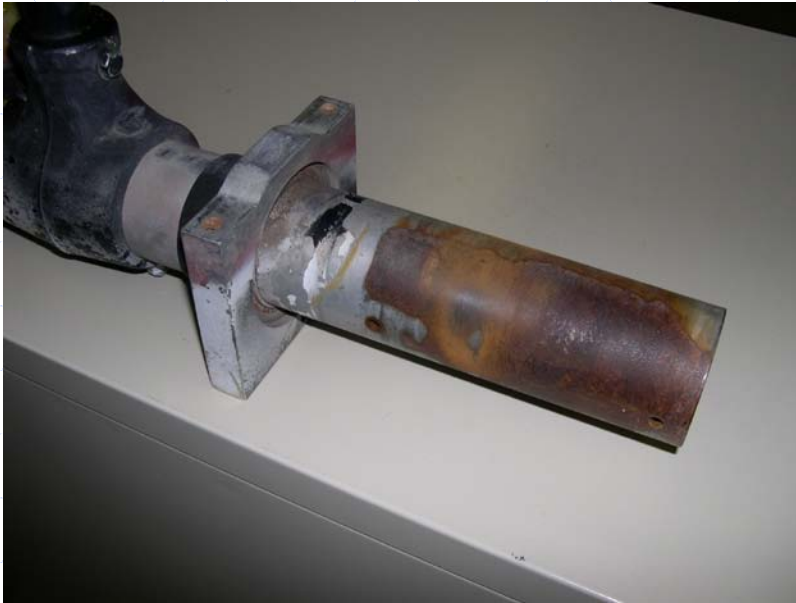
RHS as received

Torque Tube deemed unserviceable
by Altus

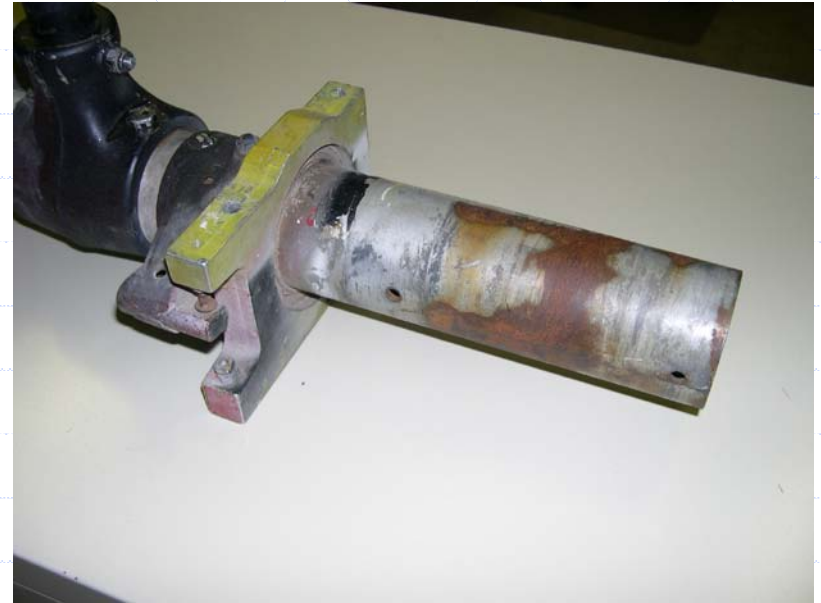
LHS as received

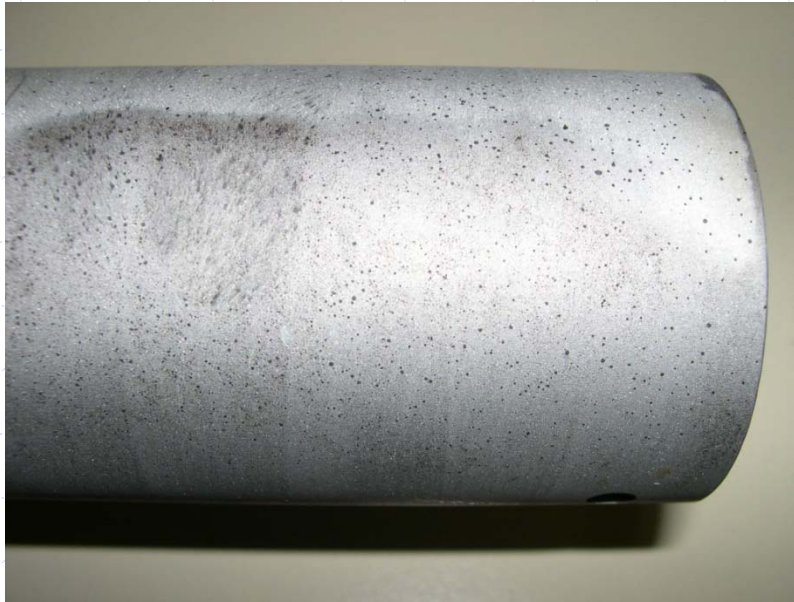
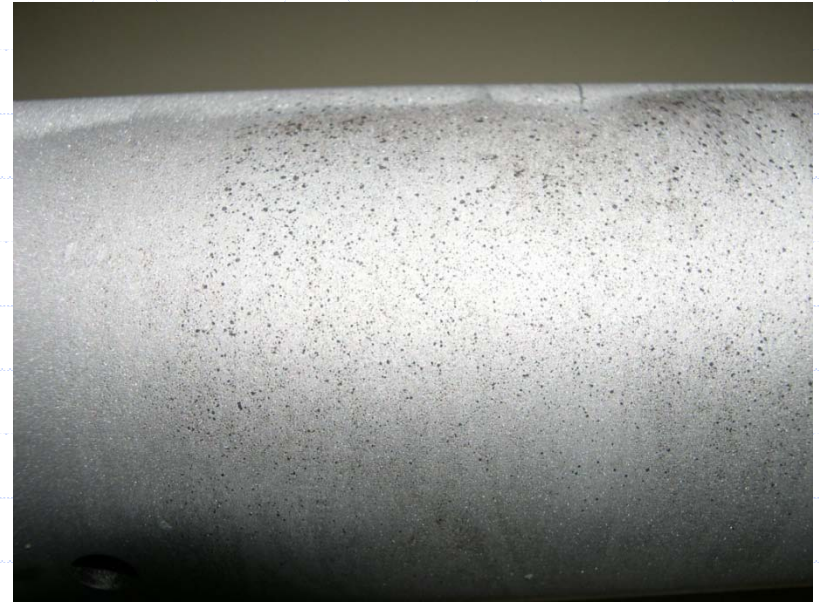
Surface Pitting after Cleanup

Diameter - LHS - Outboard Parallel/Normal to Bolt Holes	Diameter - LHS - Inboard Parallel/Normal to Bolt Holes	Diameter - RHS - Inboard Parallel/Normal to Bolt Holes	Diameter - RHS - Outboard Parallel/Normal to Bolt Holes
Parallel: 2.3106 Normal: 2.3112	Parallel: 2.3123 Normal: 2.3091	Parallel: 2.3112 Normal: 2.3100	Parallel: 2.3107 Normal: 2.3111
Ave: 2.3109 ± .0003	Ave: 2.3107 ± .0016	Ave: 2.3106 ± .0006	Ave: 2.3109 ± .0002
Overall Tube Diameter Measurement: 2.3108 ± .0016			
Per Piper Drawing - Outside Diameter = 2.3115 inches +.0003 / -.0002

- ◆ PA 24-250 unserviceable unit received from Altus
- ◆ Torque Tube cleaned up using 180 grit media
- ◆ Precise measurements made after clean up
- ◆ Coated with zinc chromate and paint
- ◆ Adapter fittings, load reaction fittings and base plate fabricated for structural testing of complete Torque Tube assembly

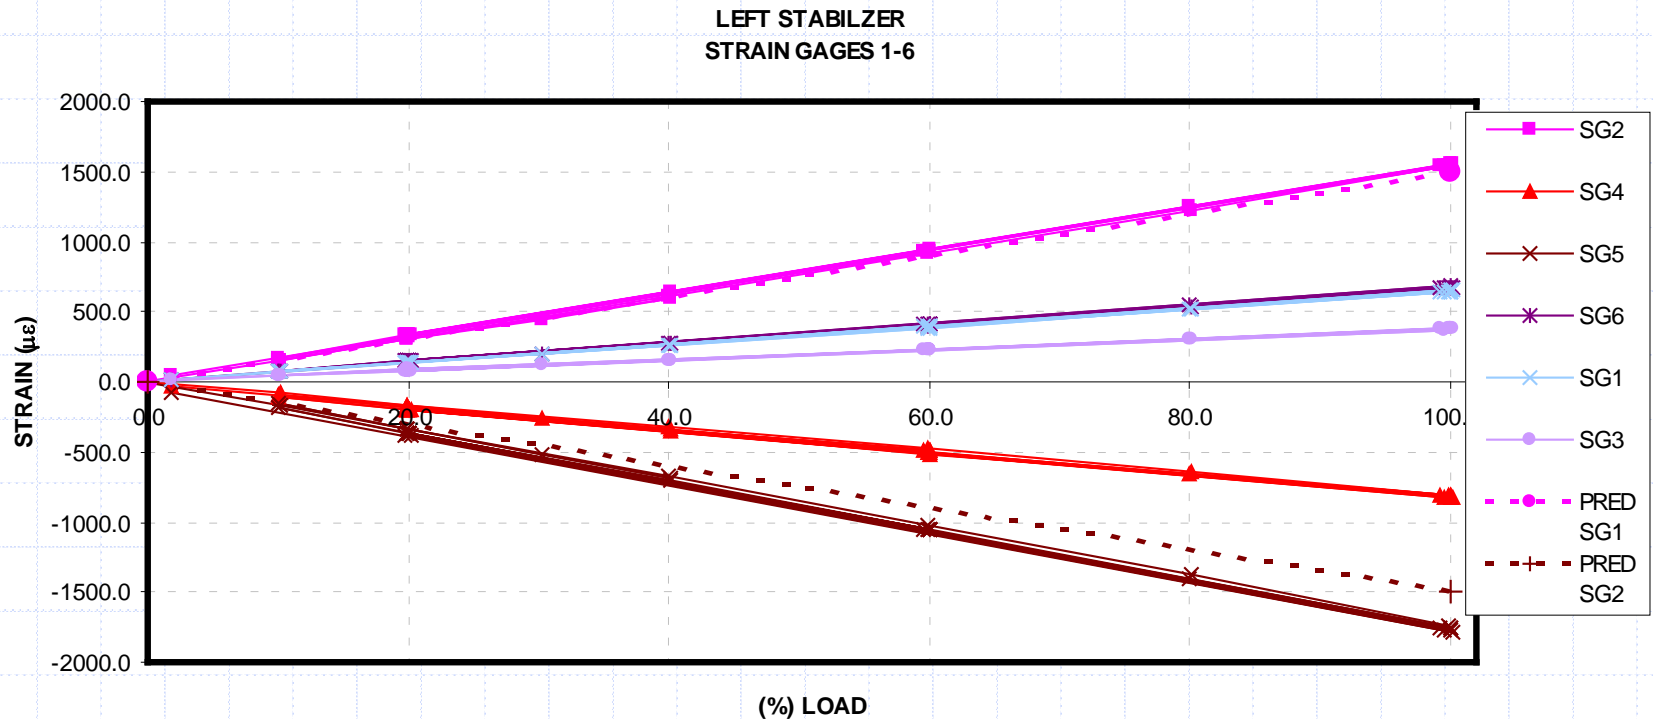
Load Case 1 Strain Data

Measured strains on torque tube. Bending stress = $27.5\text{E}6 \times \text{strain} = 27.5\text{E}6 \times .001525 = 41,938 \text{ psi}$.

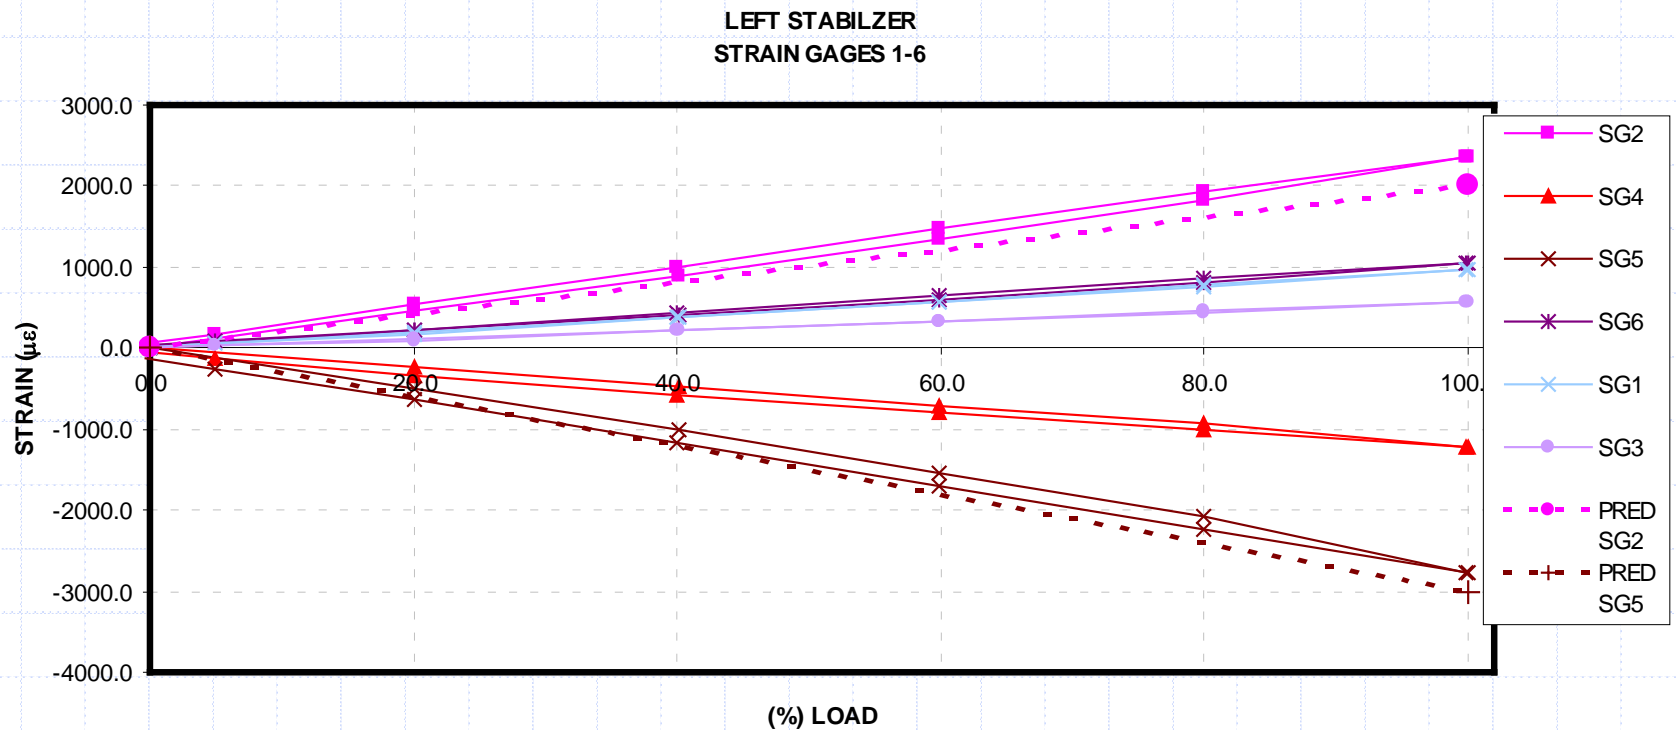
Load Case 3 Strains

All strains are still linear at ultimate load.

- ◆ An unserviceable torque assembly was refurbished and life cycle tested to DLL, and subsequently to DUL.
- ◆ Strain and displacement measurements show that during the life cycle testing, the torque tube exhibited linear, elastic characteristics.
- ◆ Corrosion on a torque tube, if found, is a Maintenance issue. These tests show conclusively that a corroded torque tube is not an Airworthiness issue.
